SafeLand

Living with landslide risk in Europe: Assessment,
effects of global change, and risk management strategies

Deliverable D1.6

Analysis of landslides triggered by anthropogenic factors in Europe

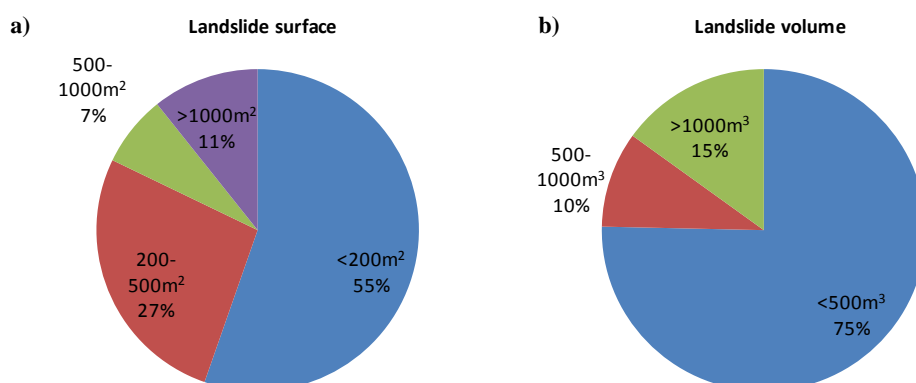
Figure 2.3.3 Percental distribution of surface area (a) and mobilised soil mass volume (b) of human-induced landslides in the Canton of Bern.

Nonetheless, there are some general trends and conclusions which can be drawn from simple statistics on human-induced landslides. Figure 2.3.3 (a and b) show, for the human-induced landslides, that around 80% of the slides in the Canton of Bern mobilise volumes of up to 500m³ (73 slides in total) and affect surface areas of up to 500m² (56 slides in total). Most slides are shallow with failure surfaces between 0.3 and 2m in soil depth. Out of 120 reported cases, 93 have a slip surface in less than 2 meters depth, 24 between 2 and 10 meters and 3 above 10 meters.

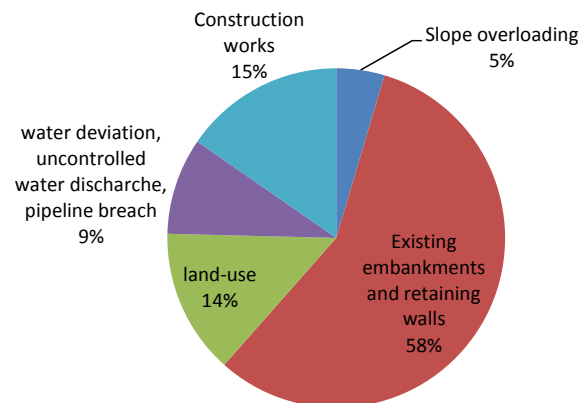
Figure 2.3.4: Human causes for landslides in the Canton of Bern.

Apart from the shallow failures, some important sliding events with more than 1000m³ are recorded as well. These cases are reported as related to either the failure of existing embankments or retaining walls in combination with high intensity or long-lasting rainfalls, failures during road construction involving the breaching of pipelines or heavy rainfall, overloading of the slope surface and the deviation of water run-off or discharge at an unsuitable location (Figure 2.3.4).

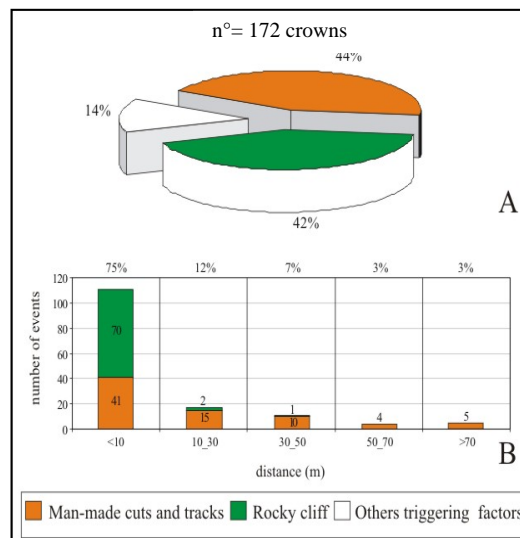
Figure 4.2.2 Statistics on sites involved in mudflow triggering (from Di Crescenzo and Santo 2005)

For a large cluster of flow-type landslides distributed across a widespread sector of Campania (172 landslides), Di Crescenzo and Santo (2005) showed that most of the first movements (45%) were located near artificial tracks (Figure 4.2.2A). In particular, 41 source areas were less than 10 metres from these morphological discontinuities (Figure 4.2.2B). Clearly, the widespread past practice of using artificial cuts to break the continuity of very steep “infinite” slopes, covered by cohesionless soils, only worsened equilibrium conditions, inducing significant changes in both surface water and groundwater circulation patterns.

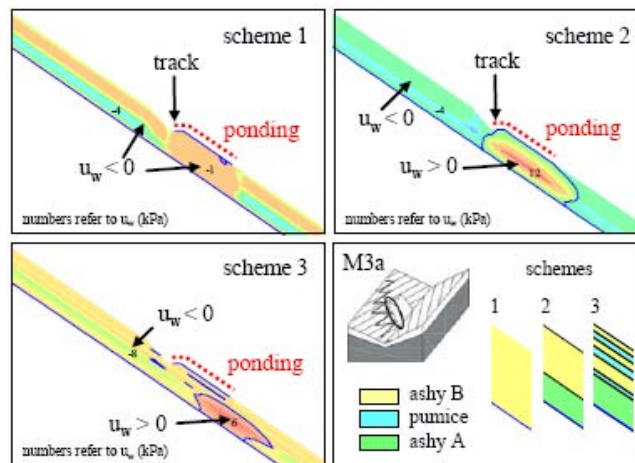
Figure 4.2.5 Results in terms of pore water pressure in three schemes analysed in the first case (Cascini et al., 2008)

that a local ponding condition causes failure involving zones both downslope and upslope of the cut when schemes 2 (ashy A and B soils) and 3 (A and B, pumice soil) are considered (Figure 4.2.4a). The same results are obtained if scheme M3b is undertaken (Figure 4.2.6). The results clearly point out the role played by stratigraphy on failure onset. Hence groundwater modelling definitively shows that ponding conditions strongly affect the transient pore water pressures, mostly depending on the local stratigraphical setting.

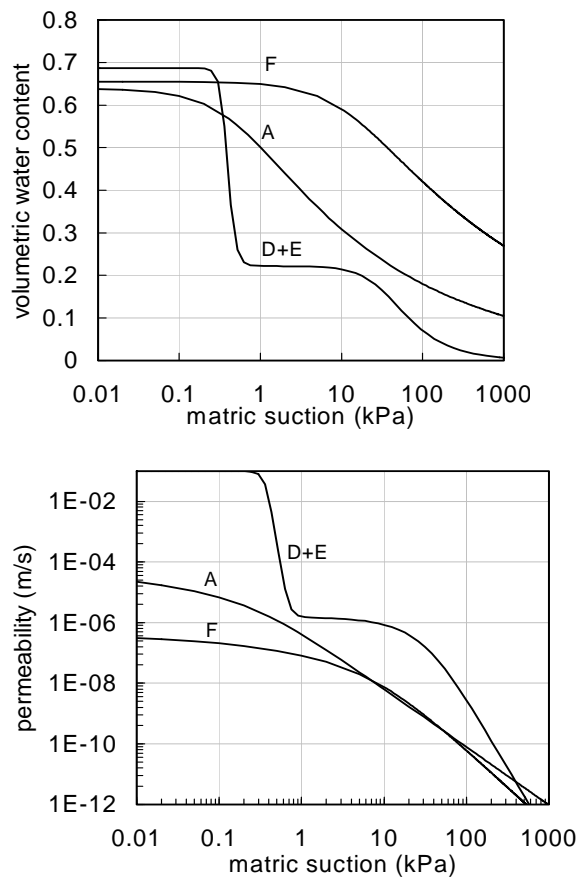
Figure 4.2.8 Retention curve and permeability function used by Evangelista et al., 2005

experimental data obtained respectively by Sorbino and Foresta (2002) and Scotto di Santolo (2000) (Figure 4.2.8). The pumice layer was modelled by the Durner model for the double porosity materials; the retention curve is the linear combination of two Van Genuchten-type retention curves, and the permeability function was obtained from the Mualem model as a function of the retention curve. The parameters for the pumice were obtained by laboratory tests performed by the same authors (Figure 4.2.8).

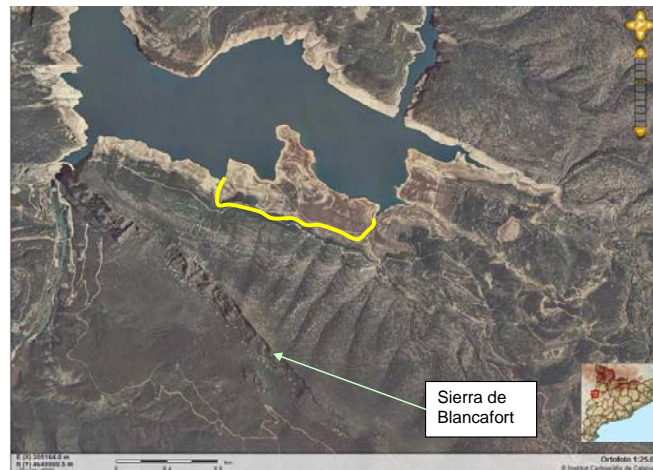
Figure 4.3.1 Aerial view of Canelles reservoir. Landslide contour indicated by the yellow line (approximate length of yellow line: 1.8 km).

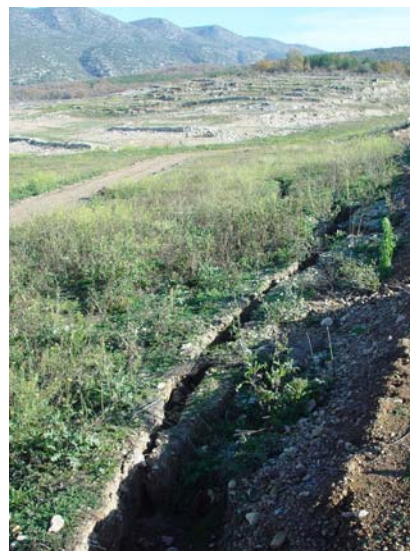
Figure 4.3.2 Detail of a tension crack at the foot of an ancient scarp. The motion of the slide (on the left) looks essentially translational.

The crack was located at the foot of continuous scarp 4 to 5 m high which was identified as a limiting boundary of an ancient slide (Figure 4.3.2).

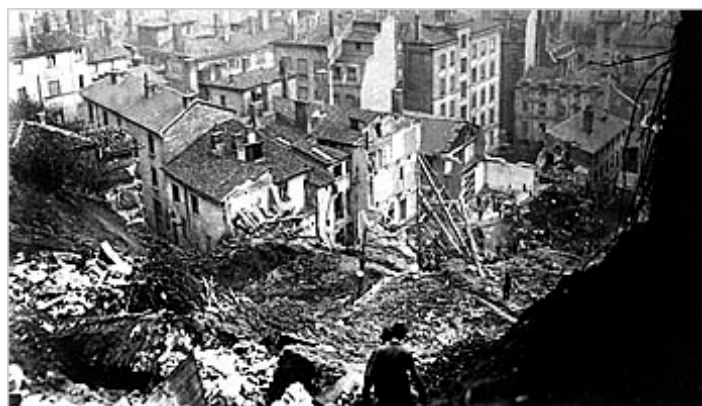
Figure 4.4.1 View of the Fourvière slide (Ref: <http://www.musee-pompier.aso.fr/>)

In the city of Lyon, France, on the hill of Fourvière (quite steep for a city), a landslide destroyed several buildings (Allix, 1930; Albenque, 1931). The landslide was triggered by an increase in pore water pressure after a period of intensive rainfalls. Soils became fully saturated because, in addition to heavy rainfall, old water canalizations and drainages were leaking due to a lack of maintenance, even though the underground network of canalizations was mapped by an architect and two geologists. Together these two additional water sources created an exceptionally unstable situation which, on November 13, 1939, led to two landslides that killed 39 people.

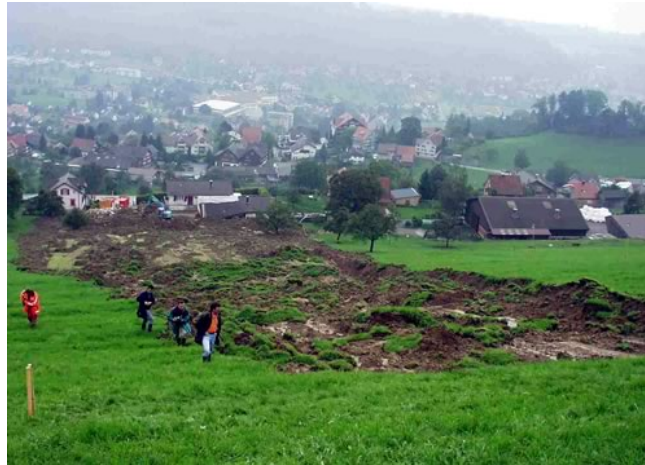
Figure 4.4.3 View of the Lutzenberg translational slide of 2002 (From www.planat.ch)

In a slope located above the village of Lutzenberg, in north-eastern Switzerland, a landslide occurred in September, 2002, which damaged three houses and killed three people. The local geological settings were favorable to landslide occurrence as the water pressure was extremely high due to the confinement of a highly permeable silty-sand layer between two low permeability layers.

Although an exceptional rainfall event triggered the landslide, back analysis and numerical modeling demonstrated that a broken water pipe found near the head of the landslide was responsible for the permanent saturation of the terrain.

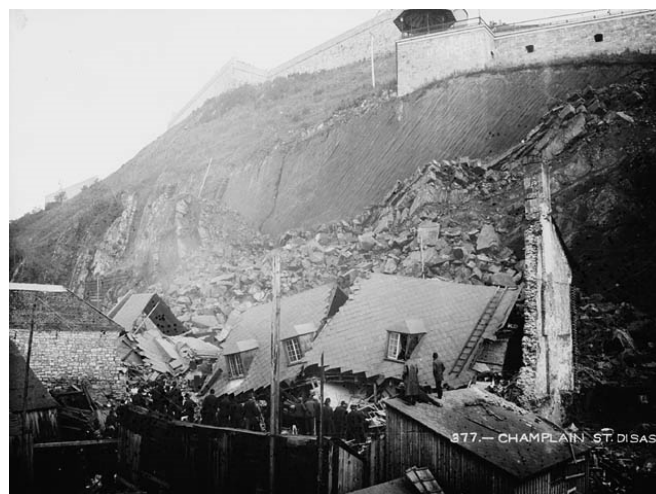
Figure 4.4.4 Quebec landslide of 1889 (From Geological Survey of Canada collection)

In Quebec City, 1889, part of the cliff along the Saint Lawrence River collapsed, killing 40 people. Although local geological conditions, such as sub-vertical bedding and metric opened cracks, were favorable to the slope failure, human activities contributed to intensified levels of slope instability; the toe of the cliff was cut several times and a leak in the upper part of the drainage system severely increased the water pore pressure. During the 11.5 hours of rainfall preceding the 1889 landslide, the drainage canalization brought 700 m³ of water to the unstable area, five times more than due to natural streaming (140 m³). The undermining of the toe of the slope and the increased pore pressure levels were the conditioning and triggering factors, respectively.

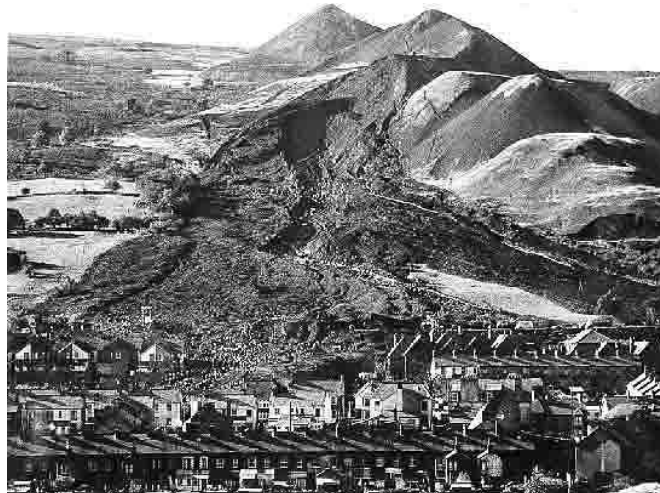
Figure 4.5.1 View of the Aberfan slide (Ref: <http://www.nuffield.ox.ac.uk>)

Mining activities in the South Wales coalfield created tailings coal debris. The stability of these human constructions was precarious on many occasions, and several unstable incidents, without grave consequences, occurred in this area. However, the Aberfan soil heap dramatically slid on the October 21, 1966, destroying buildings (e.g. a local junior school and 18 houses) and killing 144 people (116 children and 28 adults) (Bishop and Penman, 1968; Siddle et al., 1996).

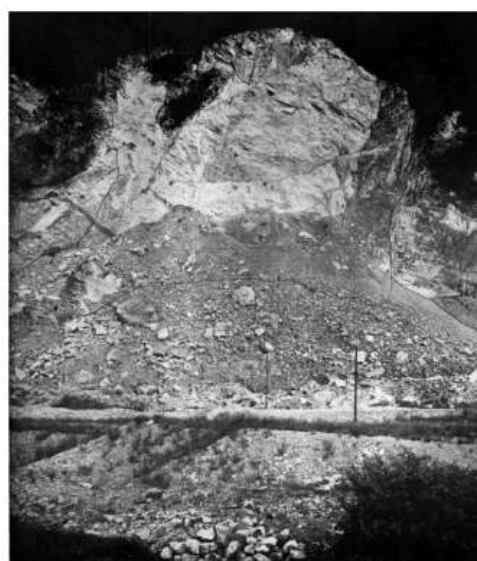
Figure 4.5.2 View of the Arvel slide of 1922 (From Choffat, 1929)

A large rockslide, involving 615,000 m³ of limestone and marls, occurred on the March 14, 1922 (Choffat, 1929; Crosta et al., 2009; Jaboyedoff, 2003; Choffat, 1929; Pedrazzini et al., 2009). Although the geometry of the slope and the orientation of the discontinuity sets were favorable to a complex failure, including wedge failure associated with toppling failure, the general destabilization of the slope was disturbed and worsened by quarry activities. This failure produced significant economic damages. Fortunately, no fatalities occurred.

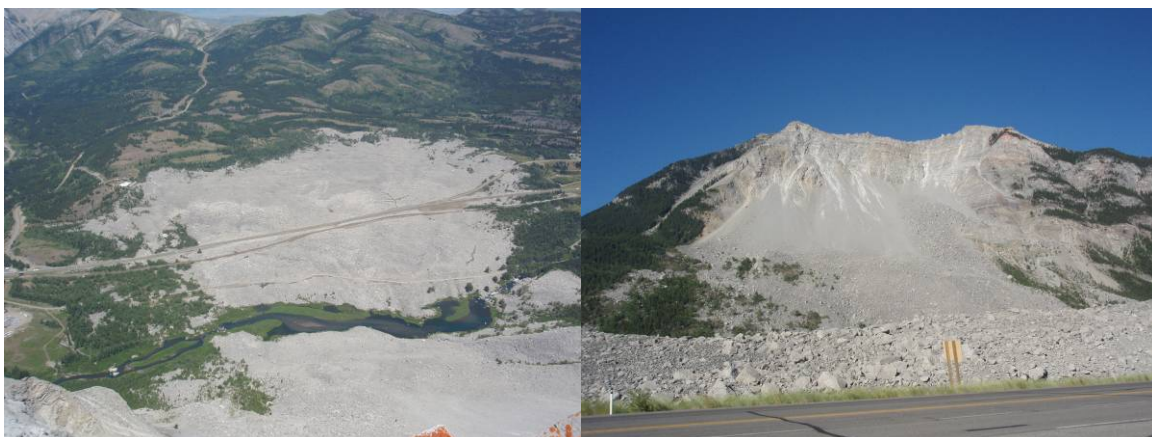
Figure 4.5.4 View of the Frank slide of the deposit and of the scar of Frank slide (IGAR-Pictures).

On April 19, 1903, a massive rock avalanche occurred in Turtle Mountain, located in the southern region of the Rocky Mountains in Canada (McConnel and Brock, 1903; Allan, 1933; Cruden and Krahn, 1973; Langenberg et al., 2006; Jaboyedoff et al., 2009; Pedrazzini et al., 2009; Froese et al., 2009). The disaster involved 30 million m³ of material and killed 70 people. Even if discontinuity sets allowed complex wedges on the top and planar dip slope on the toe of Turtle Mountain, stability conditions were worsened by mining activities, which certainly accelerated the destabilization process leading to the catastrophic failure.

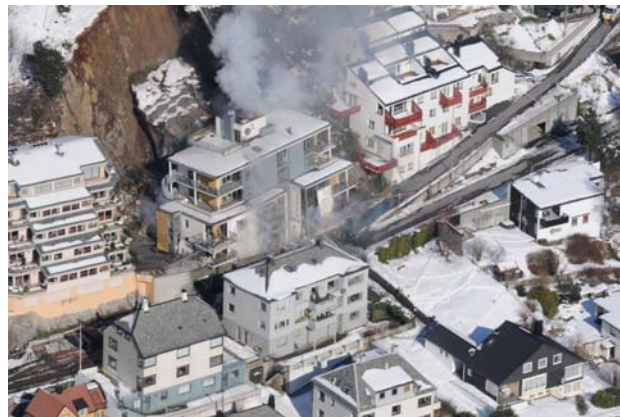
Figure 4.6.1 View of the Aalesund slide (ref: Skredulykka I Aalesund, 2008)

During the night of March 26, 2008 a 1400 m³ block slid and hit the base of a six story building in the city of Aalesund (western Norway) (Ref: Skredulykka I Aalesund, Rapport fra Aalesundutvalget, 2008). The two lower floors collapsed, causing five fatalities. In addition, a gas tank located in the basement began to leak, leading to the evacuation of approximately 500 people in the surrounding area. In order to build this two year old house, the natural rock slope was cut, creating a 20 m high vertical wall. A serious underestimation of the size of potential sliding blocks led to inadequate slope stabilization measures (anchors were too short).

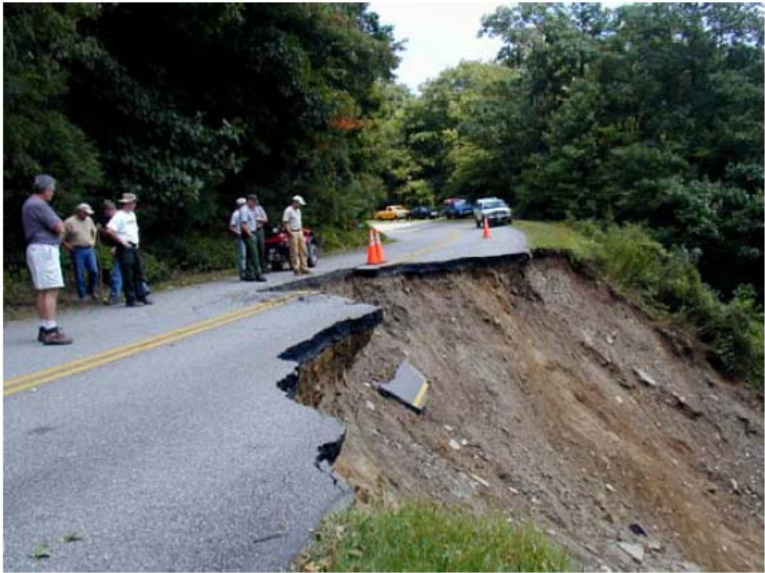
Figure 4.6.4 Example of road fill in North Carolina (USA) that initiated a debris-flow. This occurred during heavy rainfall (From Collins, 2008).

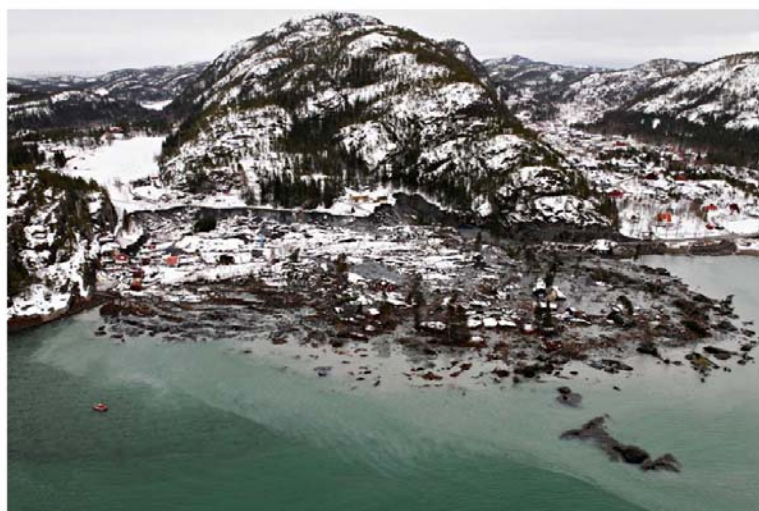
Figure 4.7.1 View of the Namsos slide (Photo by Leif Arne Holme)

On March 13, 2009, a 400,000 m³ quick clay slide was triggered by rock blasting in the vicinity of the town of Namsos (Trondelag, Norway) and ten houses were destroyed. Fortunately there were no fatalities (Ref: Skredet i Kattmarkvegen i Namsos 13 Mars 2009. Rapport fra undersøkelsesgruppe, 2009). The blasting was part of a road construction project and it took place in the bedrock very close to the limit with the sensitive clays.

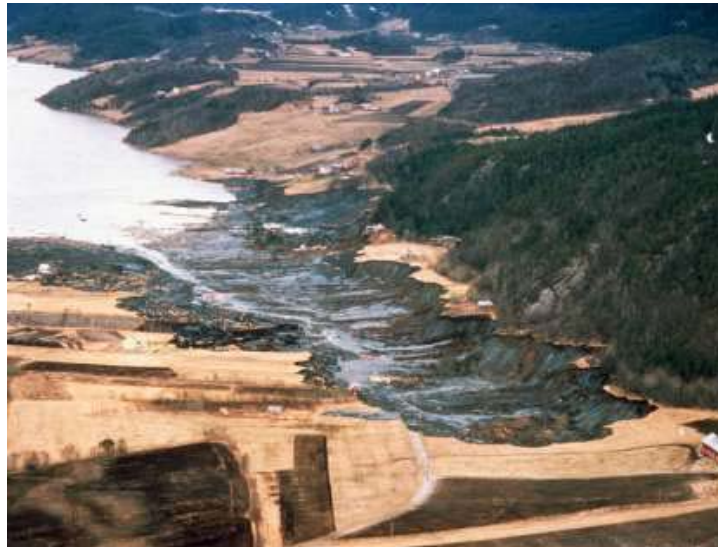
Figure 4.7.2 View of the Rissa slide

On April 29, 1978, a 5 to 6 million m³ quick clay slide took place at Rissa (Trondelag, Norway) (Gregersen, 1981). Seven farms and five houses were destroyed and one person died. The landslide was initiated by dumping of earth on the shore of a lake, in an area of sensitive clays. The slide then progressed retrogressively and eventually covered over 300,000 m². A relatively small volume of earth (700 m³) was enough to trigger one the largest quick clay slides of the twentieth century.

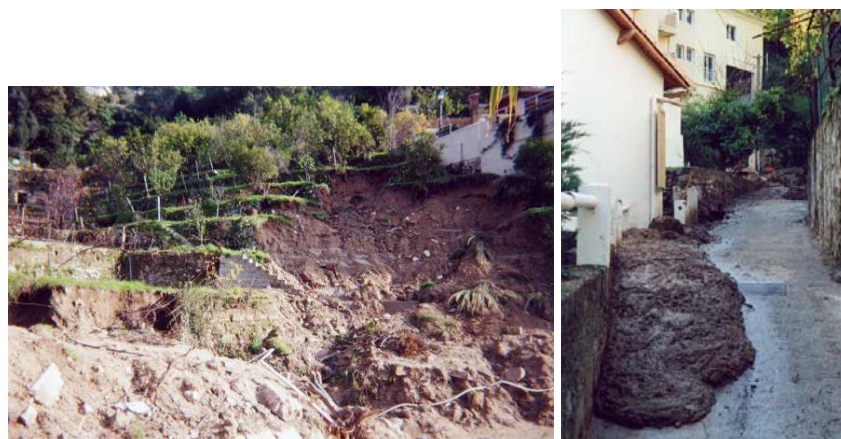
Figure 4.8.2 View of shallow landslides and mudflows

The rainfall event of November, 2000, caused more than 400 superficial landslides on the whole territory of Menton. These induced damages on buildings and created ruptures on networks and roads, but fortunately, without any injuries or fatalities. These types of rainfall events are not exceptional on the commune, but it showed the brittleness of the territory which is experiencing the consequences of fast urbanization without the organization of superficial water management.

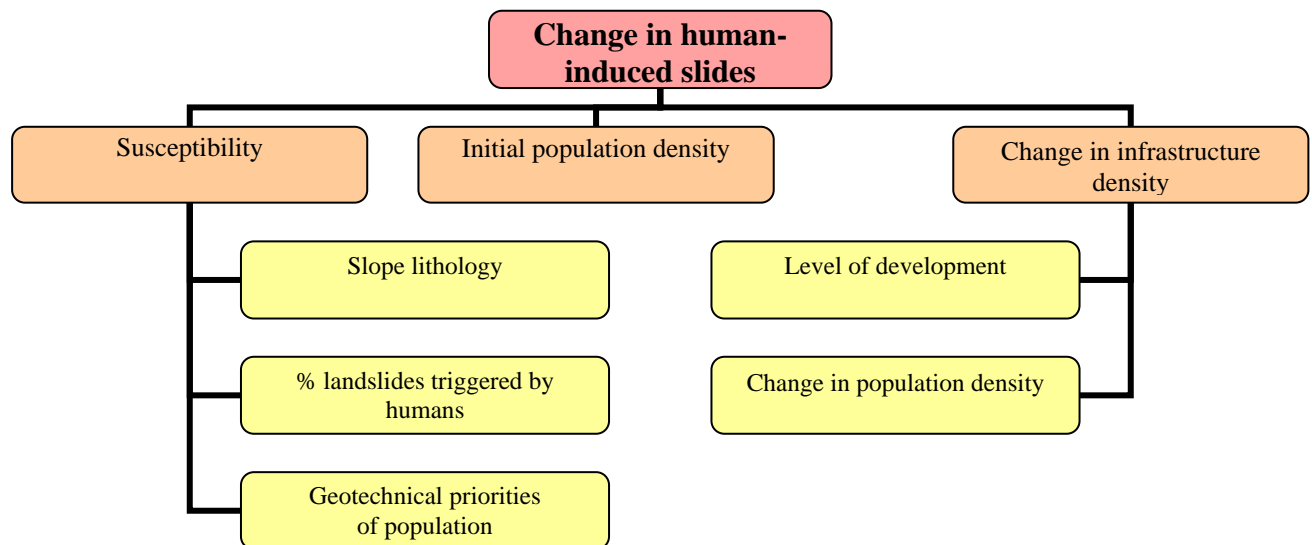
Figure 6.2.1 Parameters for SafeLand Model
